Monitoring Human-Wildlife Disturbances to Protect Sand Barrier Estuaries from Artificial Breaching

Prepared for: The Laguna Bluebelt Coalition **Prepared by:** Christina Giudice Project Manager | Orange County Coastkeeper

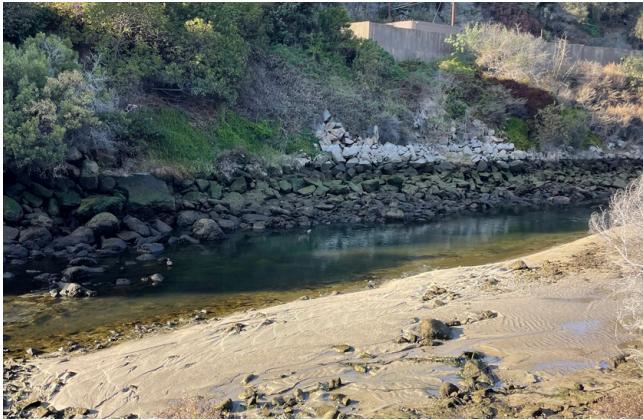
Significant Drainage of Estuary Post Artificial Breaching Event

Additionally, when people open the sandbar, this drains the estuary, killing freshwater organisms that are washed into the ocean and exposing freshwater plants to varying salinities which can hinder their growth⁹. All of these organisms, invertebrates and vegetation alike, play important roles vital for maintaining the natural function of their ecosystem. If these organisms are exposed to constant artificial breaching that causes vast variations in water levels daily, they have little to no chance of survival. Furthermore, many waterfowl rely on this vast abundance of freshwater to bathe and forage.

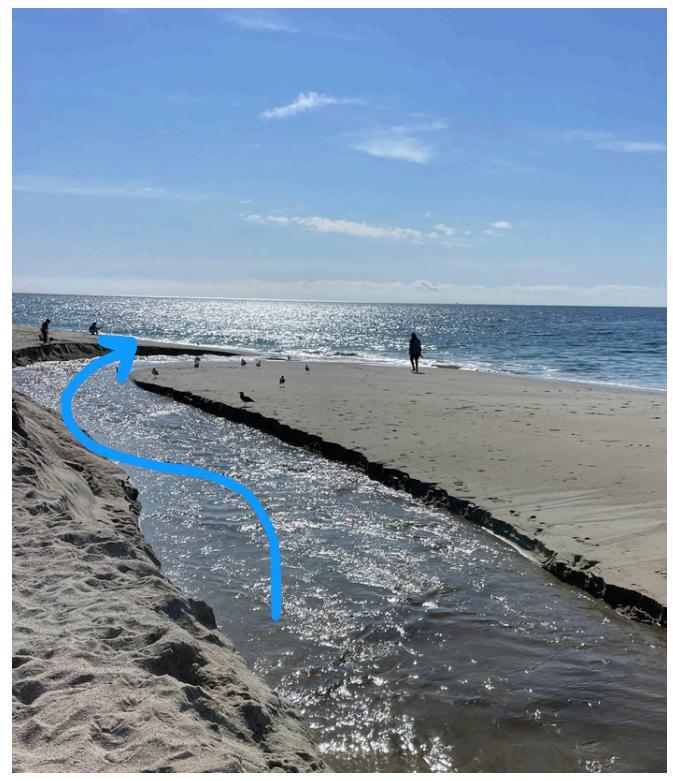
Water Flow of Naturally Open Aliso Creek

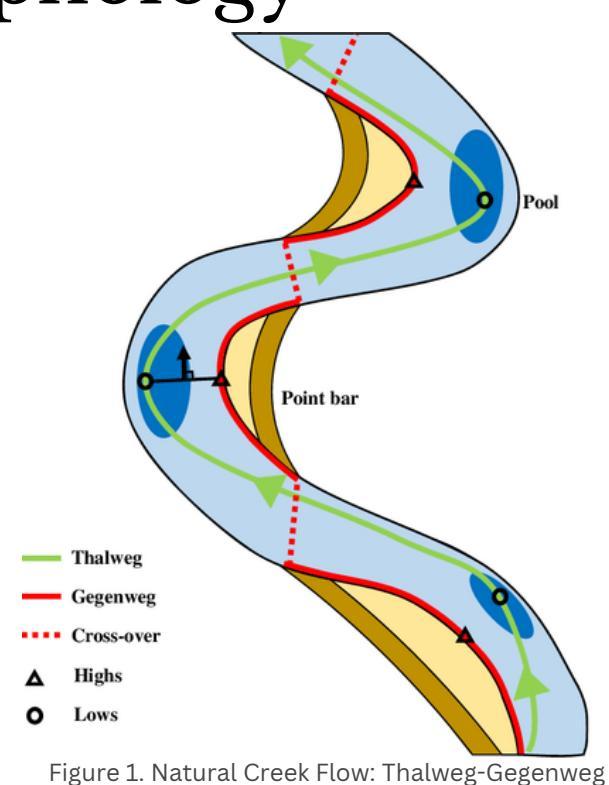
Figure 1. Natural Creek Flow: Thalweg-Gegenweg Bathymetry

Aliso Creek naturally opens once the amount of water reaches a high volume inside of the berm. These natural breaks rarely result in a straight flow to the ocean due to the "side-to-side" dynamics of water flow as seen in this drawing (Figure 1)¹¹. The flow naturally erodes either side of the stream channel, carving out the inner parts of the bank to make up for excess water flow. This is common for dry season flow considering heavy storms that result in a vast creek flushing are considerably rare.

When people break the berm in a straight line to the ocean to surf it, this counteracts the natural flow that all creeks and rivers follow. People are artificially mimicking wet season flow of the creek nearly every single day of the week, which is significantly impacting the wildlife and morphology of the berm and creek area.

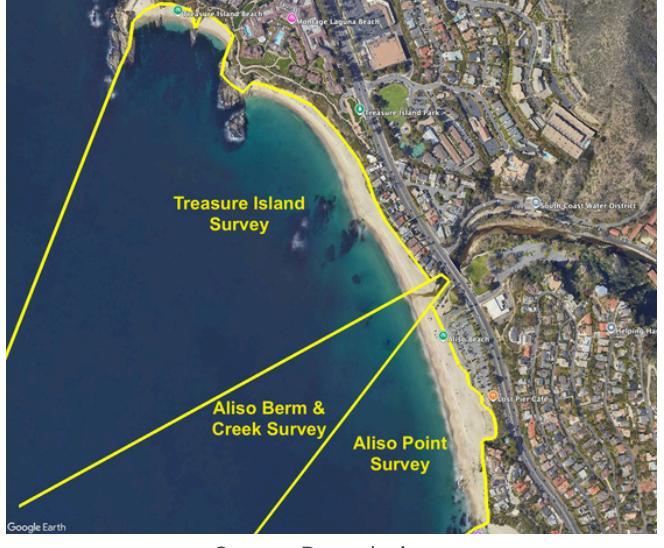
Survey Boundaries

Each surveyor would take 30-minute surveys of wildlife presence and human activity at each site. The data included site conditions, human recreational activities, wildlife presence and behavior, offshore activities, and potential violations and hazards.

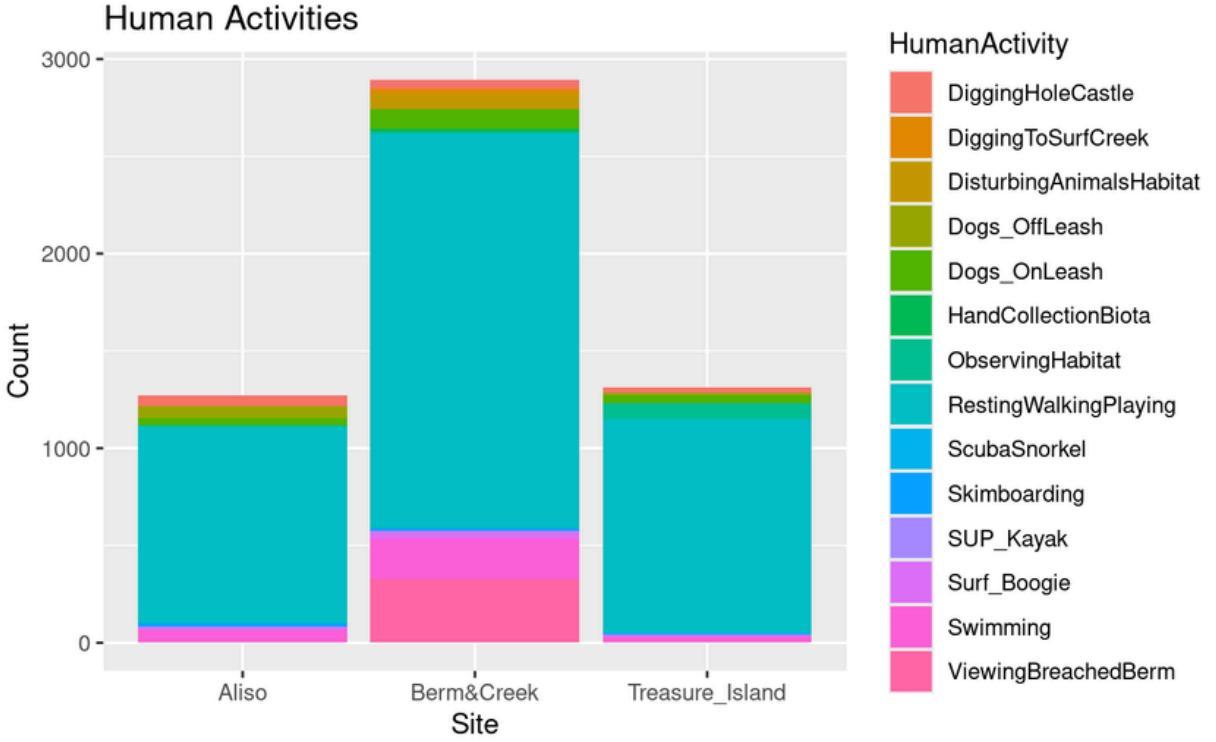
Figure 2. Graph of Human Activities

Our surveys recorded 5,475 visitors at Treasure Island, Aliso Creek, and Aliso Point in total. In the Aliso Point, Berm and Creek, and Treasure Island surveys, resting, walking, or playing were the most common recreational activities observed.

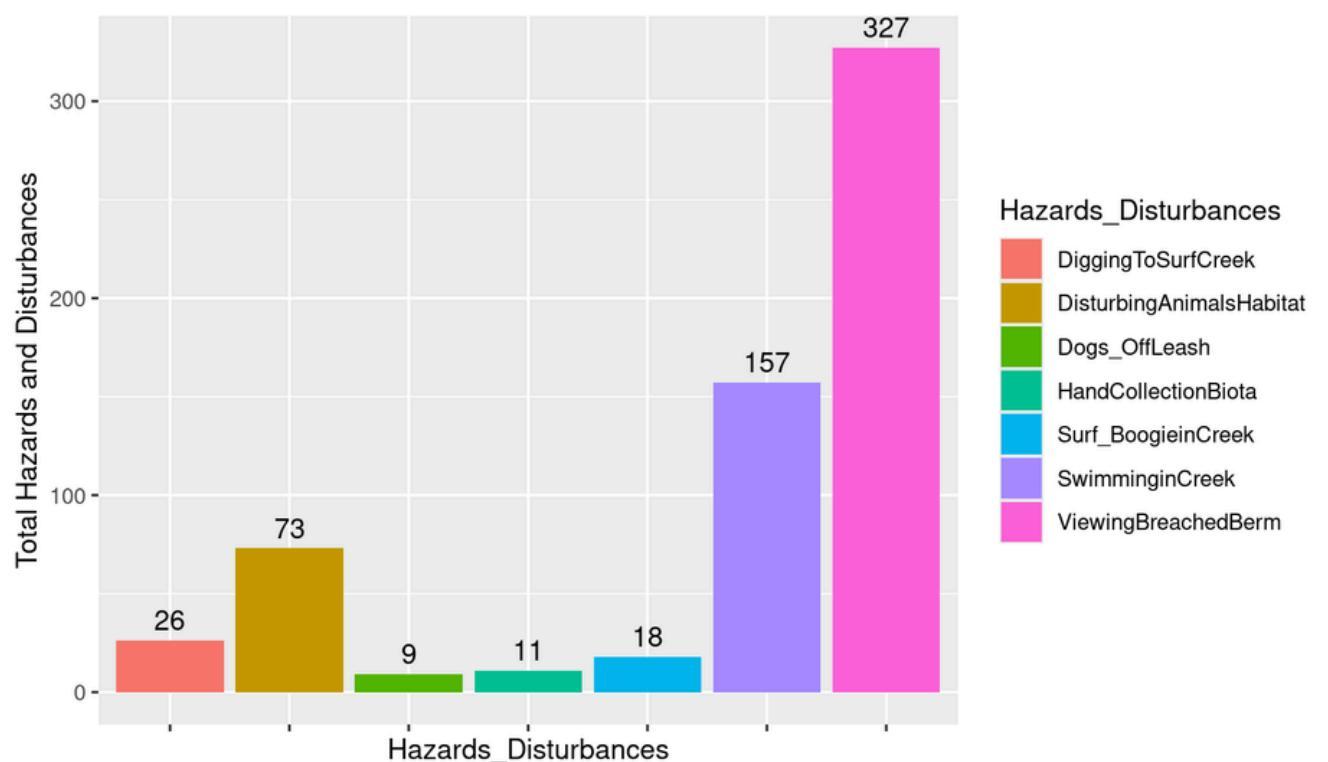
Figure 3. Graph of Hazards and Disturbances in the Berm and Creek Area

The Berm and Creek area alone faced a total of 621 observed hazards and disturbances. The most common hazard in the critical habitat included viewing the breached berm. The most common disturbance was disturbing animals and habitat. With additional findings that are not included in our graphs, we found that the berm had been breached more than 60 times in 2024. With the help of outside information, we learned that the berm was being broken multiple times a week but we were only able to observe it on-site during structured surveys 26 times. It is important to keep wildlife disturbances to a minimum in the Marine Protected Area to prevent potential damage to these critical habitats.

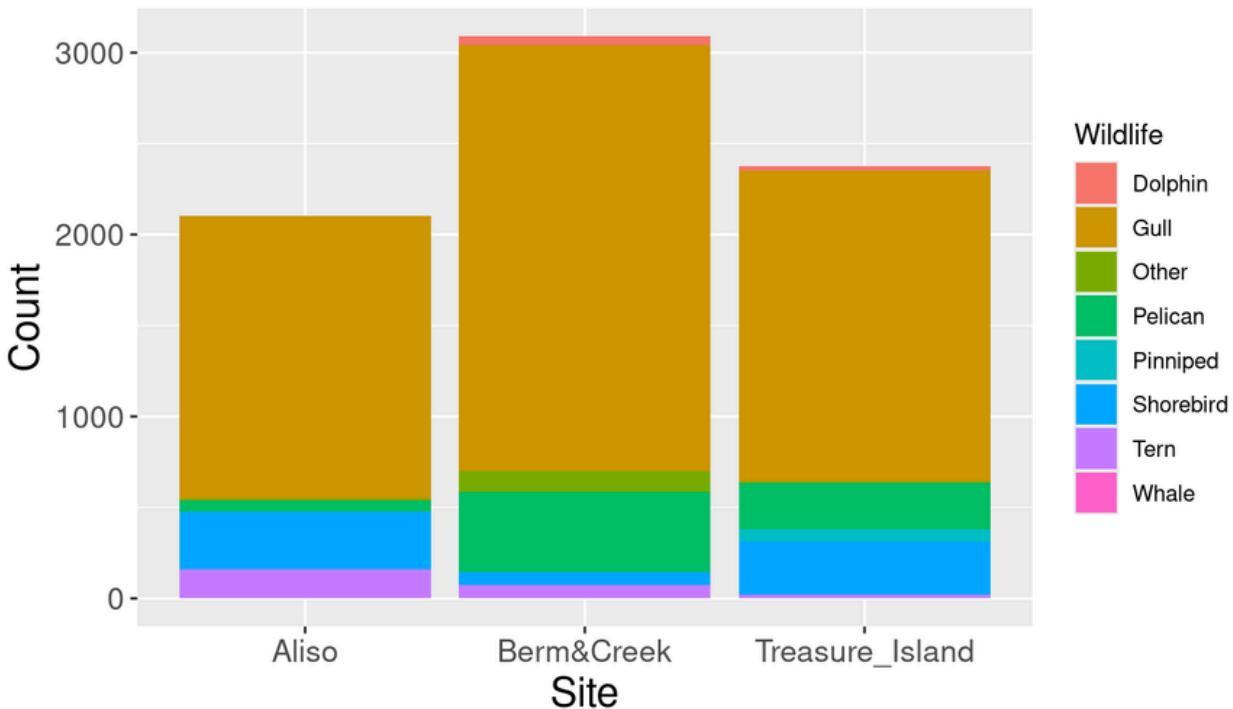
Figure 4. Wildlife Observations Across the Three Sites

According to our breakdown of the wildlife data collected in 2024, gulls were the most prevalent. Additionally, there were high amounts of birds present at all locations including terns, different kinds of shorebirds, pelicans, cormorants, ducks, coots, egrets, and many more. However, there were a few harbor seals and sea lions spotted at Treasure Island and pods of dolphins at all locations.

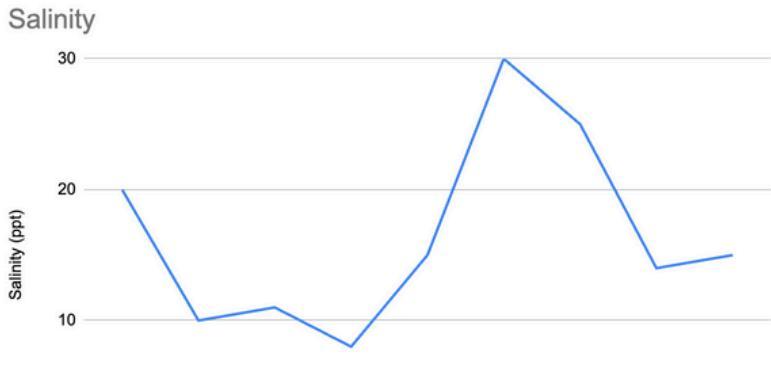
Figure 5. Salinity in Aliso Creek in Parts Per Thousand

Our research assistants also gathered salinity data and found that the salinity ranged from **8 ppt-30 ppt** in two different sampling points behind and in front of the Aliso bridge. This tells us that Aliso Creek falls under **brackish** conditions that are defined in salinities from 0.5–35 ppt. With this information, Enterococcus would be the most applicable fecal indicator for this brackish ecosystem.

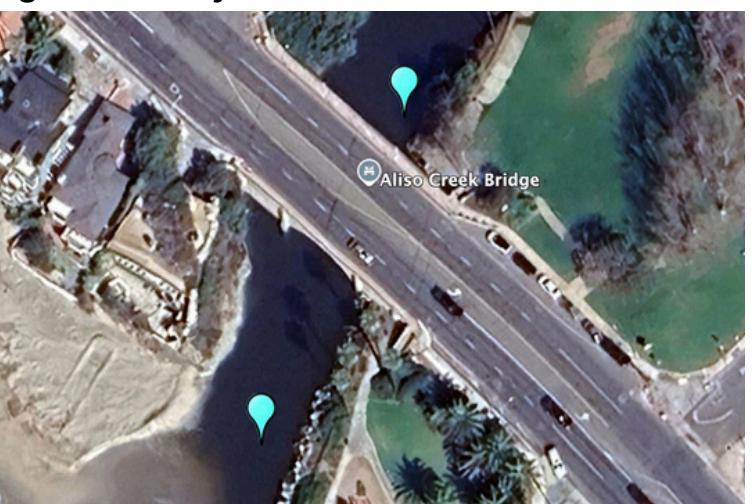
Two salinity sampling points in Aliso Creek via Google Earth

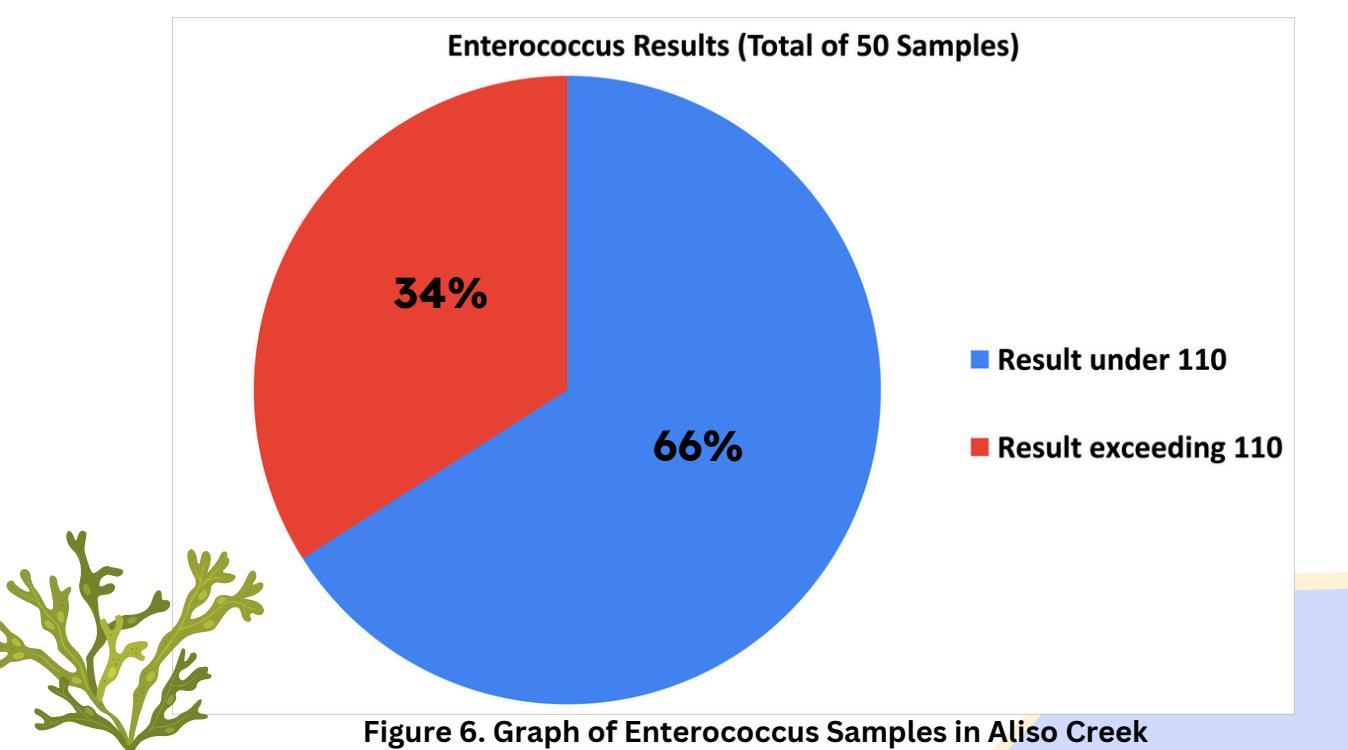
Of the 50 samples collected in Aliso Creek, 17 exceeded bacteria standards, which was 34% of the samples. Meanwhile, 33 samples met bacteria standards, making up 66% of the data.

Our research assistants acquired water quality data from the County of Orange to evaluate the presence of fecal indicators in Aliso Creek while it was open to the ocean. The standards for fecal indicators are created by the USEPA and California State Water Board. The standard for Enterococcus in marine or brackish environments is 110 colony-forming units. A colony-forming unit is defined as a single bacterium or group that can form a visible colony and provides information about how much bacteria is in a given sample.
